Property Inspection Report

Home Inspection

Sample Report

**777 Landmark Lane
Landmark, CA 92591**

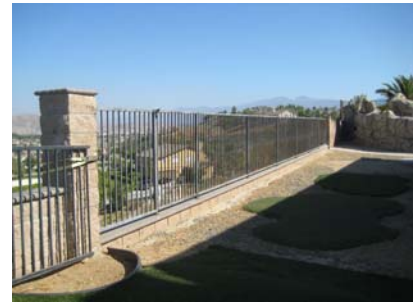
Fences

Wrought Iron fencing at the north and east boundaries are not secured at the base and or not installed correctly.

Recommend contacting a Fencing Contractor to make corrections.

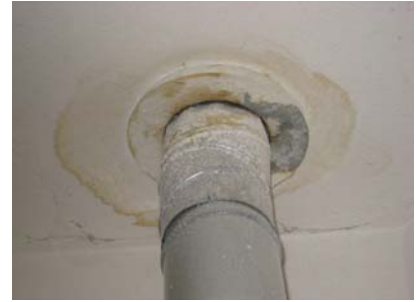
Water Heater

1. The cabinet base is too weak to carry the load weight of the hot water heater.
2. Observed water stains on the ceiling at the vent penetration. NOTE: The cause could possibly be from lack of proper ventilation through the doors that cover the compartment. Recommend adding vents to the doors or removing doors.
3. The water inlet copper fitting is leaking. Recommend contacting a Plumbing Contractor to make corrections.

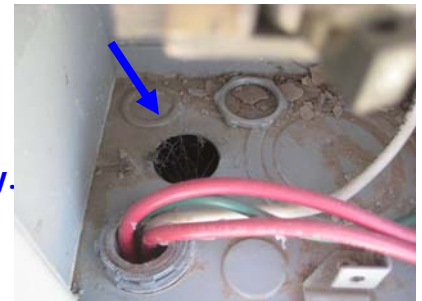
Main Panel

1. Breakers labeling is faded. Needs to be relabeled for breaker identification.
 2. Observed 1-50 amp 2 pole breaker off for Air Conditioner. Turned on for testing purposes / Satisfactory.
 3. Observed 1-30 amp 2 pole breaker off.
 4. Observed 1 single pole breaker not in use in the off position.
 5. Observed a 1/2" knock out missing at the base of the main panel.
- Recommend contacting an Electrical Contractor to make corrections.

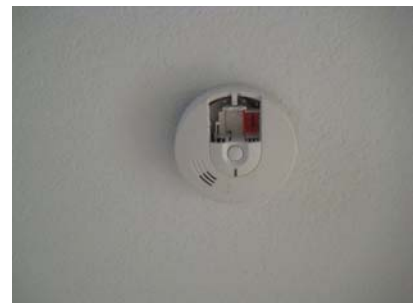
Smoke Detectors

**All smoke detectors tested in good condition.
1. Several of the back up batteries were missing.
Recommend replacing all back up batteries throughout the house.**

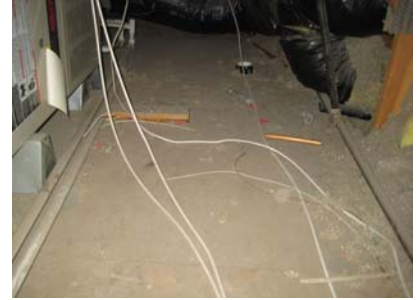
Ceiling Frame

Observed debris on the attic floor that the heating system rest on.

Recommend cleaning out debris and dust from around the heating system.

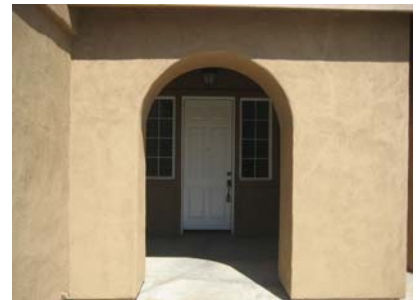
Entry Doors

The front main entrance door does not latch smoothly. Needs adjusting.

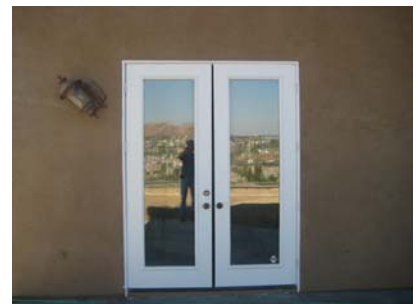
Other Entry Doors

The fixed door to the french door system at the south east corner of house needs locking hardware repaired.

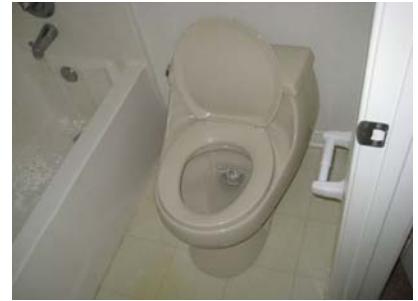
Toilets

The toilet is not secured to the floor securely. Recommend contacting a Plumbing Contractor to make corrections.

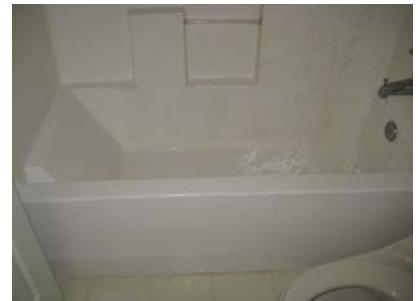
Bathtub

- 1. The diverter valve is corroded and is stuck in shower position.**
- 2. The drain stop is missing.**

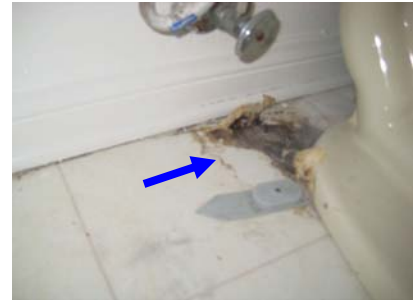
Toilets

Comments: (Immediate Attention Required)
The toilet is not secured to the floor securely and is leaking waste onto the floor behind toilet.
Recommend contacting a Plumbing Contractor to make corrections.

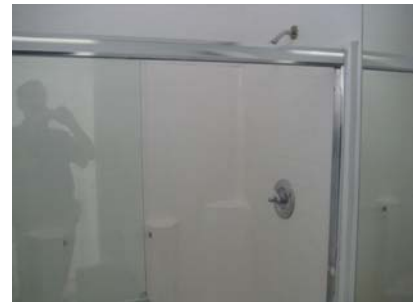
Shower Walls

Comments:
The shower door stop track is missing.

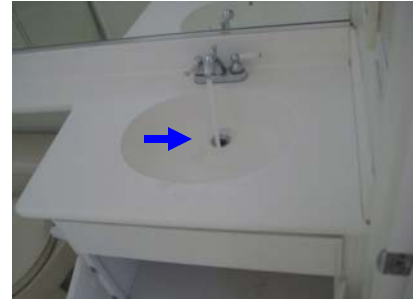
Sinks

Missing drain stop.

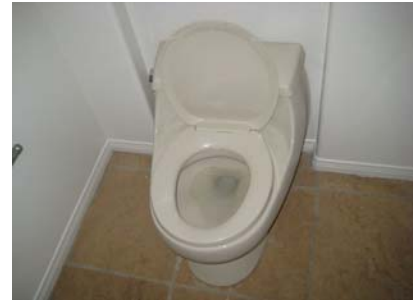
Toilets

**The toilet is not secured to the floor securely.
Recommend contacting a Plumbing Contractor
to make corrections.**

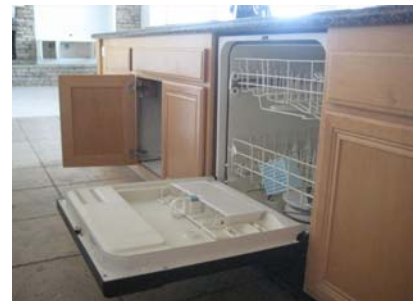
Dishwasher

The Air Gap is clogged and draining water on top of the counter top and down inside the base cabinets. The disposal is not operating correctly and is clogged.

Recommend contacting a Plumbing Contractor to make corrections.

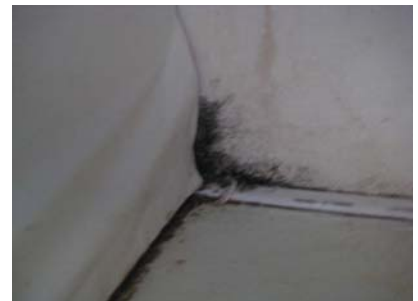
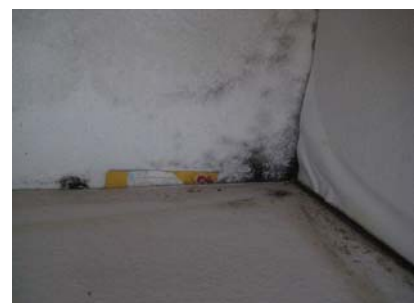
Moisture and Mildew

1. Observed Mold and Mildew in the base cabinet under the sink and the cabinet to the left of sink. The Air Gap was clogged and leaking on top of the counter down inside of the cabinet when testing the dishwasher. This could have been the cause of the moisture that led to the presents of mold and mildew.

Recommend contacting a Mold Inspection Laboratory for further recommendations.

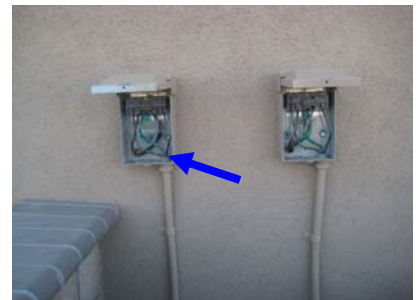
The inner disconnect cover is missing. Recommend contacting a Heating and Air Conditioning Contractor to make corrections.

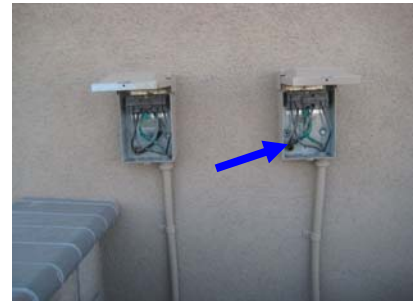
**The inner disconnect cover is missing.
Recommend contacting a Heating and
Air Conditioning Contractor to make corrections.**

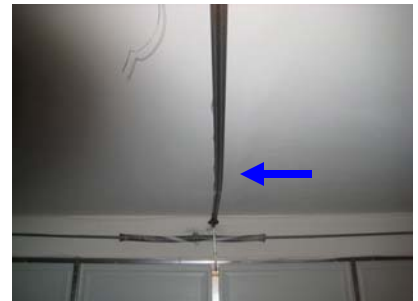
Door Opener

Vehicle garage door opener to the east garage has a bent tracking rod.

Recommend contacting a Vehicle Door Company to replace tracking rod.

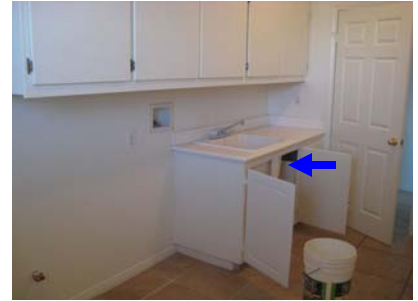
**The utility sink drain leaks.
Plumbed for gas dryer only.**
