Property Inspection Report

Home Inspection

Sample Report

**777 Landmark Lane
Landmark, CA 92591**

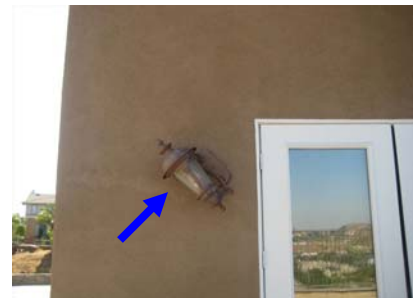
Comments:

The exterior light fixture at the south east corner of house is not secured.

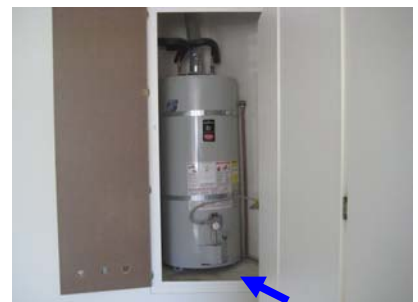
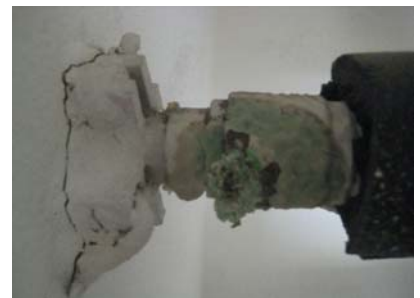
1. The cabinet base is too weak to carry the load weight of the hot water heater.
2. Observed water stains on the ceiling at the vent penetration. NOTE: The cause could possibly be from lack of proper ventilation through the doors that cover the compartment. Recommend adding vents to the doors or removing doors.
3. The water inlet copper fitting is leaking. Recommend contacting a Plumbing Contractor to make corrections.

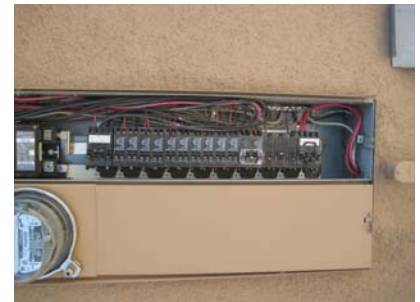
Main Panel

1. Breakers labeling is faded. Needs to be relabeled for breaker identification.
 2. Observed 1-50 amp 2 pole breaker off for Air Conditioner. Turned on for testing purposes / Satisfactory.
 3. Observed 1-30 amp 2 pole breaker off.
 4. Observed 1 single pole breaker not in use in the off position.
 5. Observed a 1/2" knock out missing at the base of the main panel.
- Recommend contacting an Electrical Contractor to make corrections.

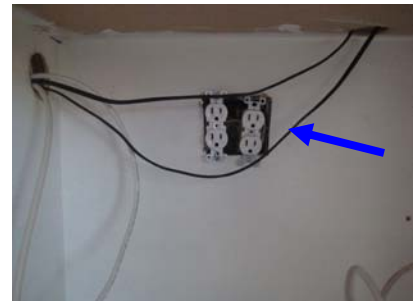
Observed an electrical outlet inside the cabinet to the entertainment center in the living room that needs to be secured to electrical box and have a cover plate installed.

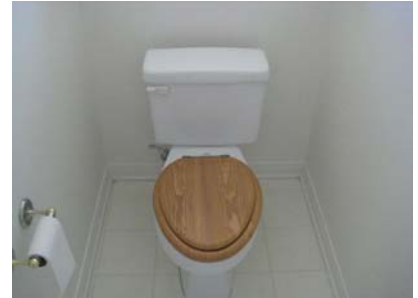
The toilet is not secured to the floor securely. Recommend contacting a Plumbing Contractor to make corrections.

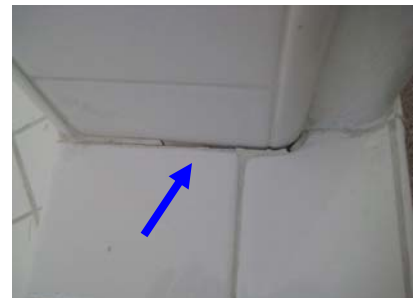
There are several areas that the grout is cracking and needs to be re-grouted.

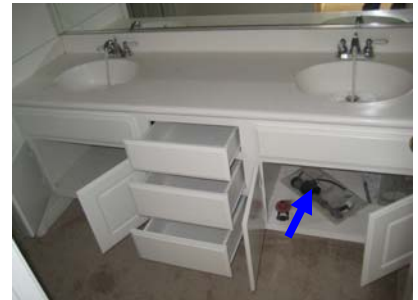
The right sink hot water L-Stop is frozen.

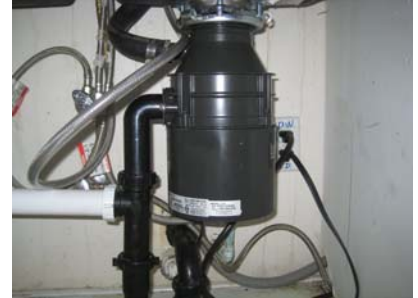
Comments:

The disposal is jammed operating sporadically. Recommend contacting a Plumbing Contractor to make corrections.

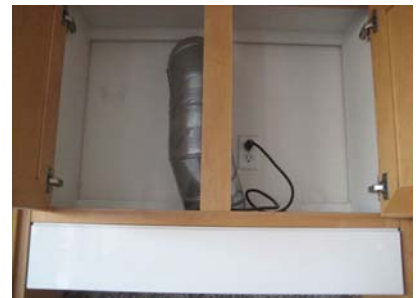
Condition: Needs Maintenance
Fan Vents To: Exterior

**The exhaust hood fan does not operate.
Recommend contacting an Appliance Contractor
to make corrections.**

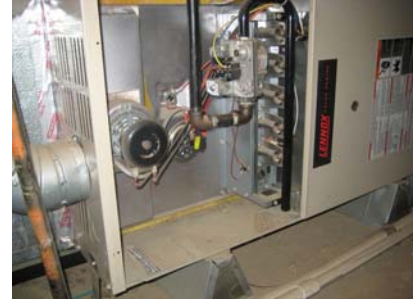
Condition: Needs Maintenance

1. There is excessive dust and debris outside and inside of the heating unit.

Recommend contacting a Heating and Air Conditioning Contractor to clean and service unit.

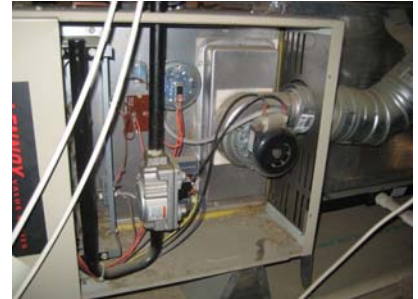
Condition: Needs Maintenance

1. There is excessive dust and debris outside and inside of the heating unit.

Recommend contacting a Heating and Air Conditioning Contractor to clean and service unit.

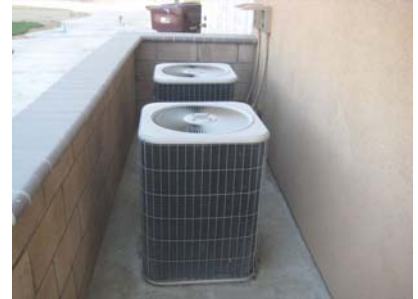
Note: The 50 amp breaker was off at the time of the inspection. Turned on breaker for testing purposes. Turned breaker off after inspecting. Tested OK. Recommend monitoring breaker and Air Conditioning unit for an abnormal behavior on account of the breaker being in the off position before the inspection.
